**SUB:-STUDY & ANALYSIS OF TG#1 TURBINE VALVES STUCK-UP & ITS
SERVICING & OVERHAULING**

STUDY REPORT
ON
TURBINE VALVES (ESV) OF TG#1
AT RGTPP

RAJIV GANDHI THERMAL POWER PROJECT
HISAR, HARYANA

SUBJECT:-STUCK –UP PROBLEM OF TUEBINE VALVE ATRGTPP

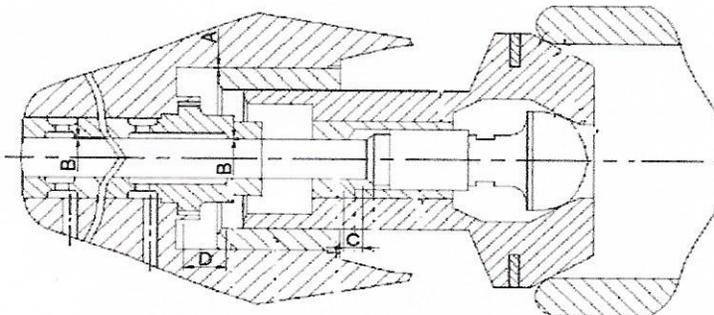
When a turbine valve fails to shut properly during an emergency turbine trip or normal shutdown, a turbine over speed event can take place, resulting in catastrophic failure of the turbine and generator components; as well as endangering the lives of plant personnel. These kinds of events can be avoided by careful periodic testing, inspection and maintenance of valves and proper valve testing.

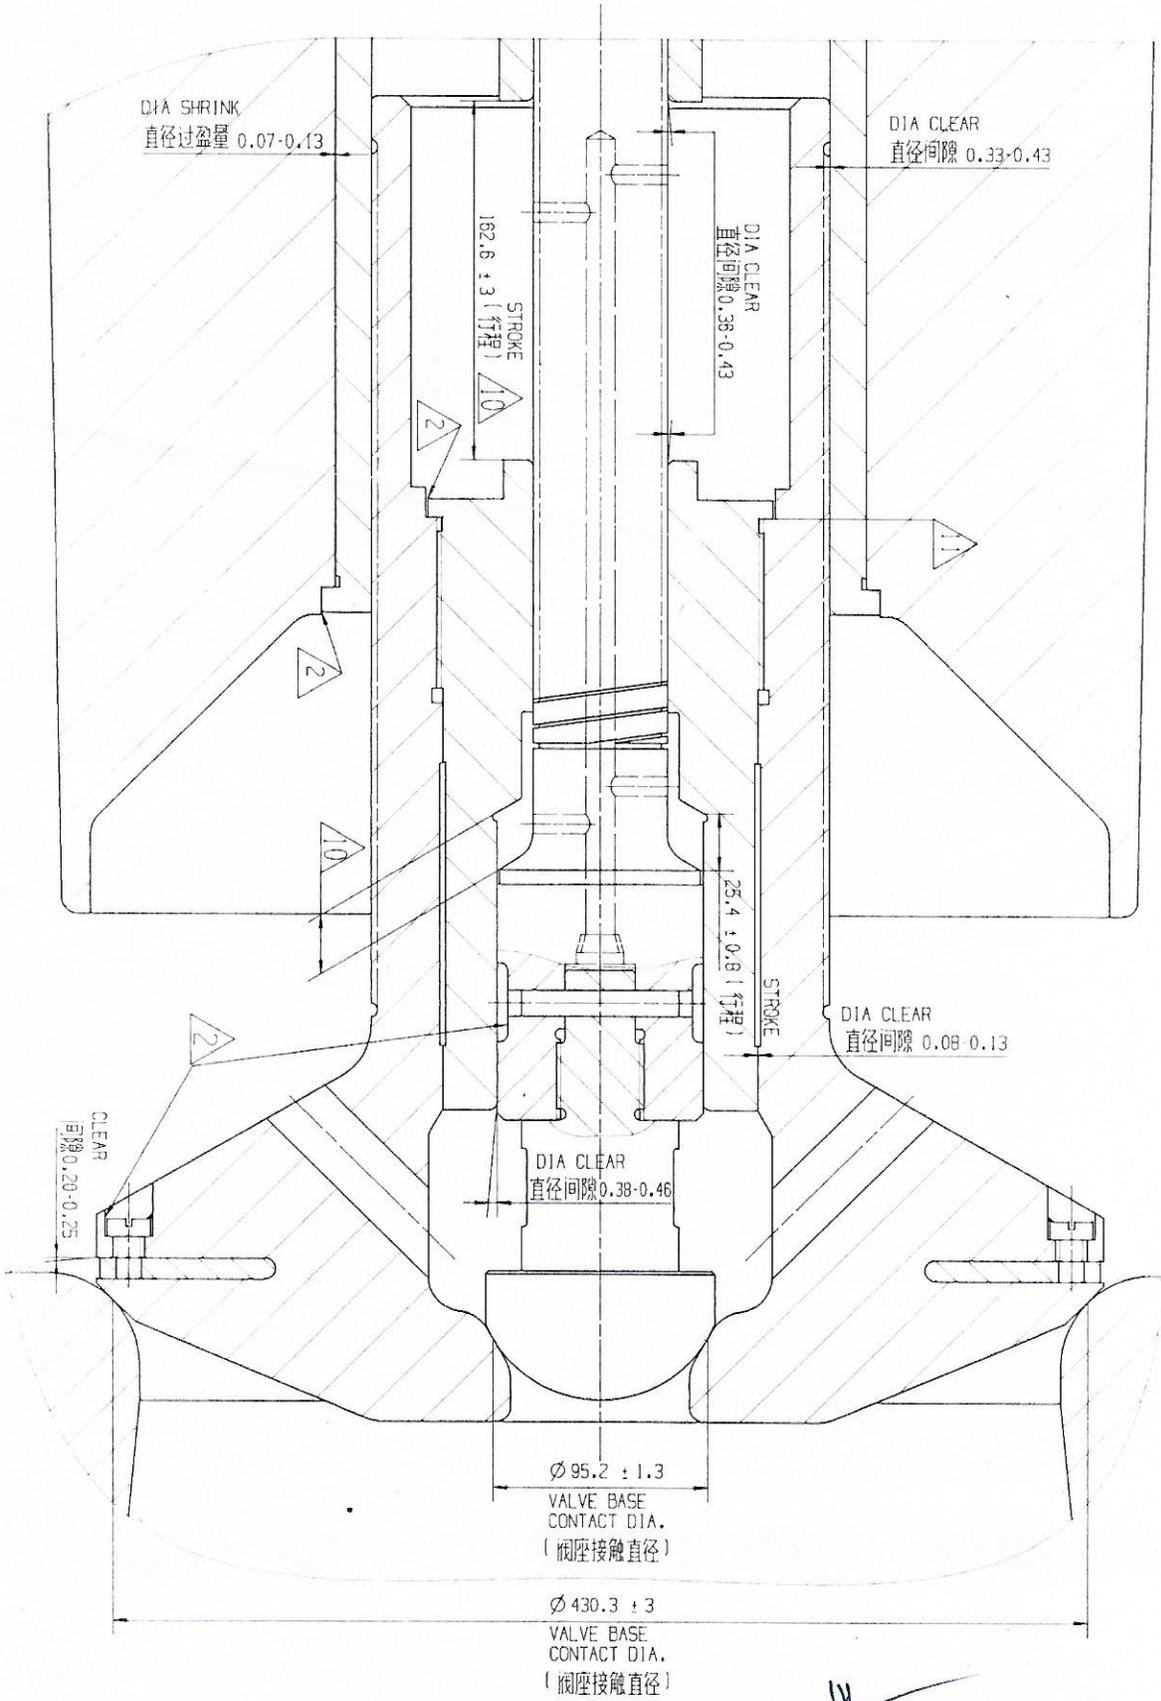
Although steam turbine over speed events seldom happens, when they do, their effects can be very catastrophic and potentially dangerous to life, causing millions of Rupees in destruction to turbine generator components. In hydrogen-cooled generators there also is an added risk of explosions from the generator hydrogen.

The key to avoid all these undesired outcomes is **a properly scheduled steam turbine valve inspection carried out on predetermined intervals.** Most valve inspection outages vary between a **two- to a four-year cycle,** depending on the original equipment manufacturer (OEM) recommendations and **operating conditions of the individual plant (depending on PLF and running hrs).**
