**Subject :-High Vibration Spikes Problem of TG#1 ( BRG #9) OF RGTPP**

**UNIT TG#1 HIGH VIBRATION SPIKE AT BEARING NO #9**

**Rajiv Gandhi Thermal Power Project (RGTPP)**  
**Khedar, Hisar**

### Subject:-VIBRATION SPIKES AT RGTPP TG #1 AT BRG NO#9

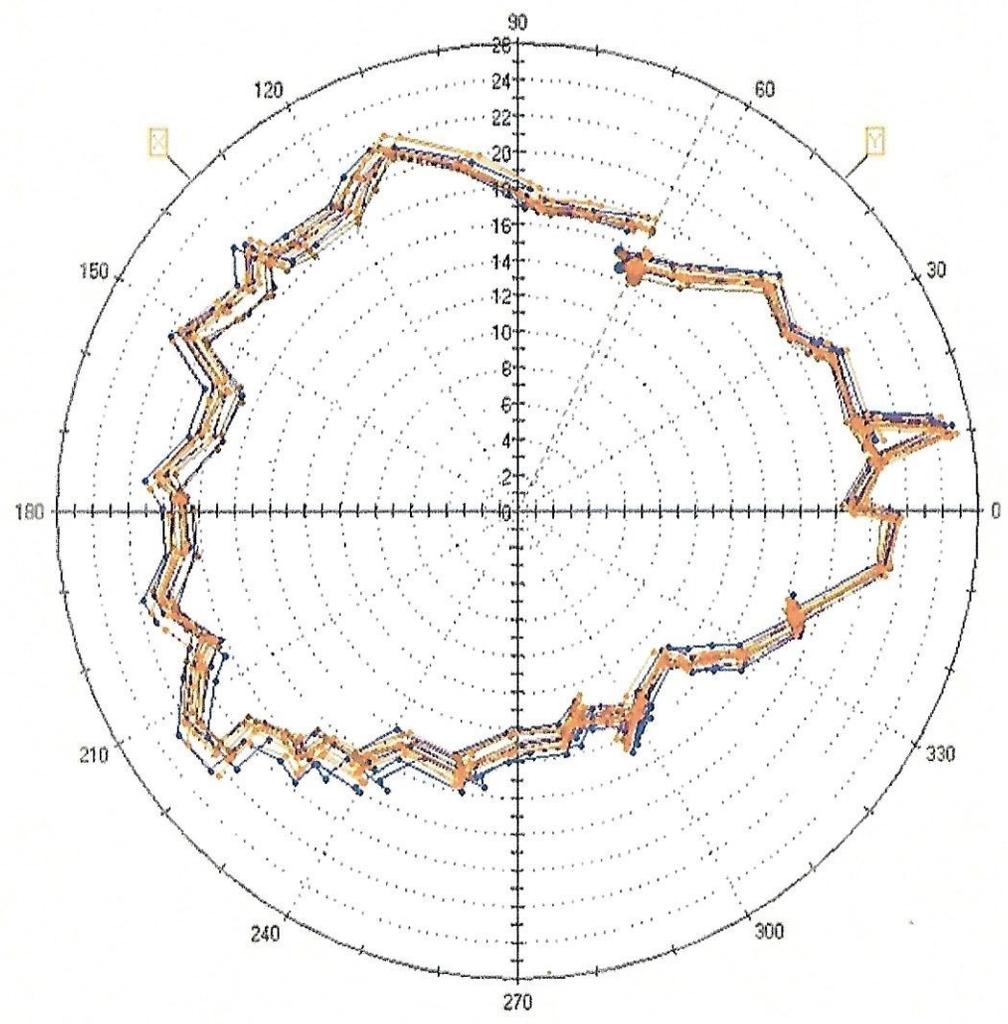
### TDC

X - probe	
Point :	#9 SV-X
Time :	79.69 ms
Amplitude (X) :	5.62 $\mu$ m

Y - probe	
Point :	#9 SV-Y
Time :	79.69 ms
Amplitude (Y) :	16.35 $\mu$ m

Orbit	
Point :	#9-Orbit
Phase :	63.98 °
Amplitude :	17.29 $\mu$ m

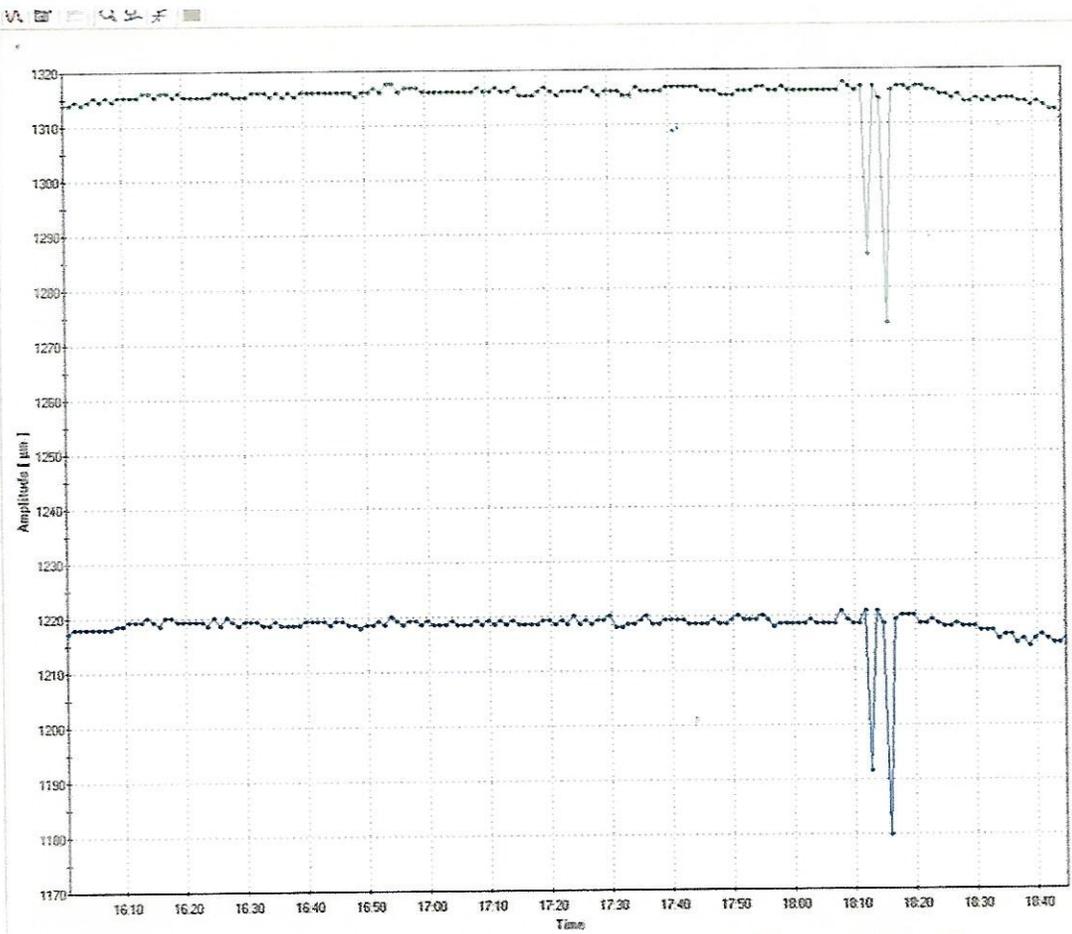
Bog (no) 9

- i) The observation in BRG#9 is standalone having no consequential change in any other bearings.
- ii) No relationship could be established with any operational parameters with BRG#9 high vibration spikes .
- iii) There is no relationship between dip in gap voltages and vibration spikes. Refer **(Annex-V)**
- iv) No electrical parameters are causing the subject abnormality (high vibration spikes) .Refer **(Annex-II)**.
- v) It is obvious from the data that there is no mechanical side abnormality and the repeated incidents of high vibration spikes could be spurious. This may be due to malfunctioning and erratic behavior of cards. Stray current due to transient earthing of control cables cannot be ruled out.
